Lightsource BP
Prosiect Maen Hir – Central
Anglesey
Phase 1 Geo-Environmental Assessment

July 2024

Document Number:	MSF-BWB-ZZ-XX-RP-YE-0002_Ph1-Central					
BWB Reference:	232062

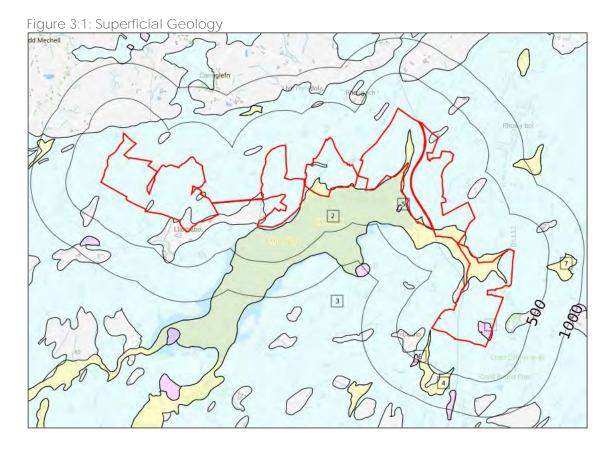
- 3.3 Information published by the BGS indicates that a large proportion of the site is underlain by Devensian Till superficial deposits, indicated by the pale blue areas on Figure 3:1 below. Localised pockets of Alluvium (clay, silt, sand and gravel) are mapped along the water courses and in close proximity to Llyn Alaw (yellow areas).
 - Superficial deposits are locally absent across the site.

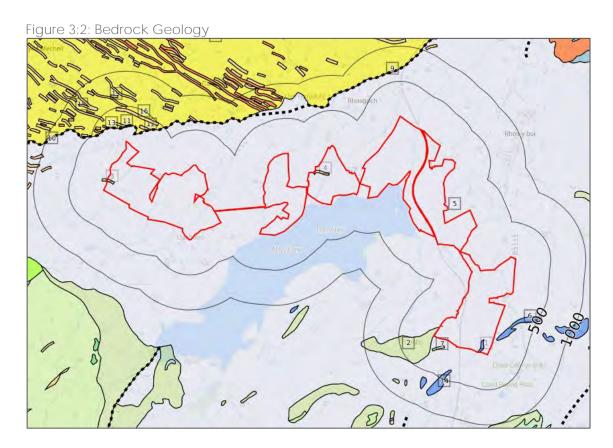
3.5 The underlying bedrock predominantly comprises Ordovician Rocks (interbedded mudstone and sandstone) across most of the site (pale grey areas on Figure 3:2). Igneous intrusions of gabbro, microgabbro and diorite are mapped in the west (ref. 3) and central (ref. 4) areas.

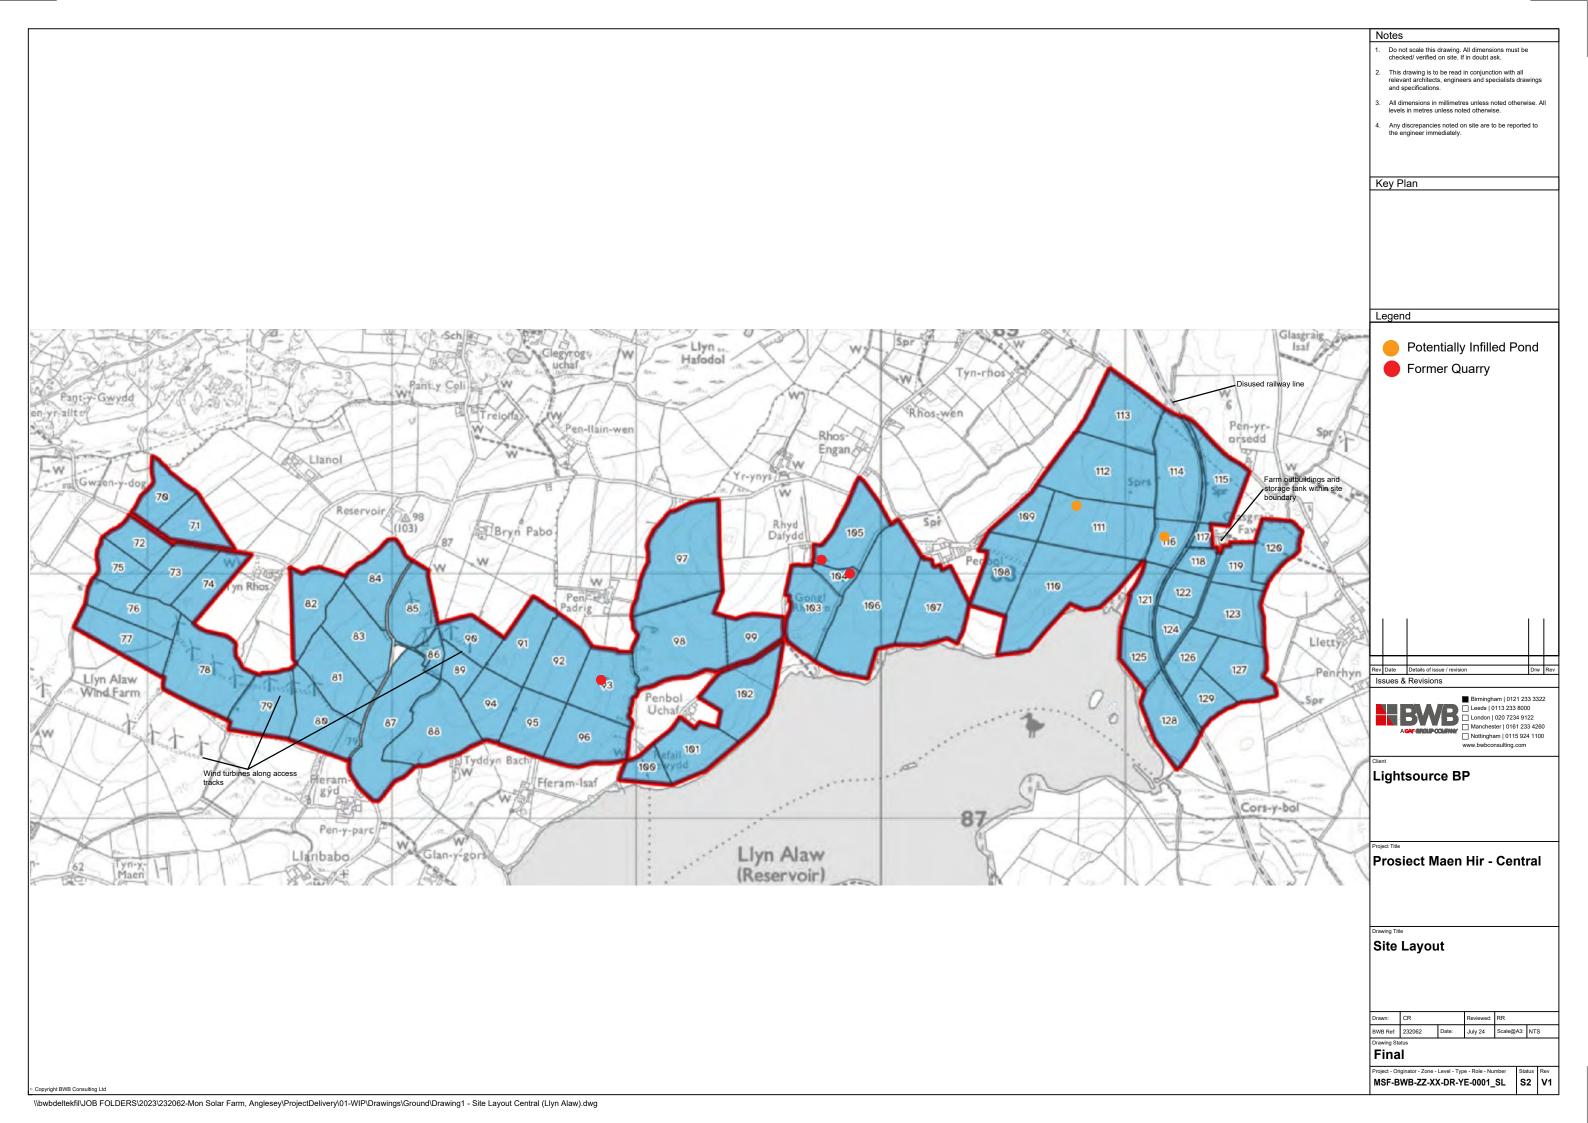
Drawing 1: Site Layout Plan

- 2.2 The site comprises an irregular shaped parcel of land covering an area of approximately 390 hectares, centred around Llyn Alaw. BWB undertook a site walkover on 15th and 16th August 2023, selected photographs are presented in Appendix 1. A site layout plan is presented within Drawing 1.

4.1 Historical Ordnance Survey (OS) mapping for the site area has been reviewed. These maps and plans date from 1887 to 2023. The historical plans reviewed are provided in Appendix 3. The key points of the historical development of the site and surrounding area are summarised below, with pertinent locations shown on Drawing 1.

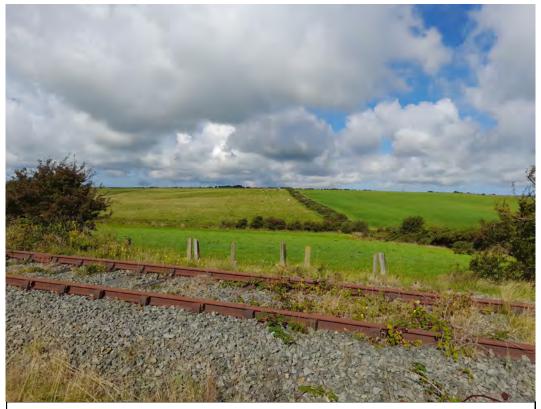
Photo 2—Disused rail siding to east of Llyn Alaw.

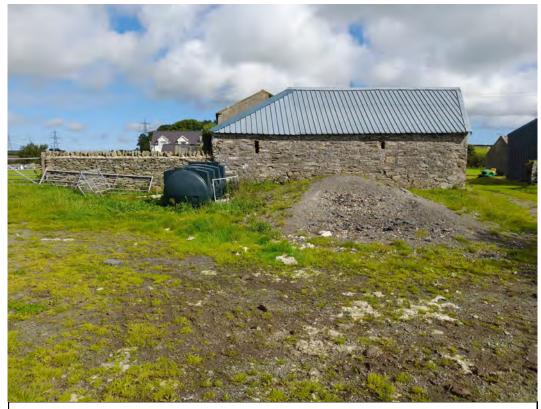
Photo 4—Off site farm building with storage tank to north east of lake.

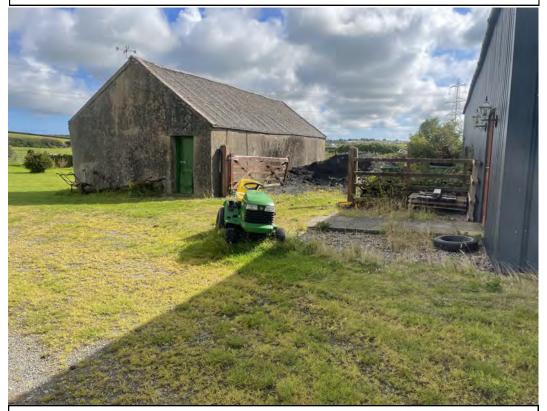
Photo 5—Farm buildings adjacent to fields east of Llyn Alaw. Possible asbestos containing materials within building fabric.

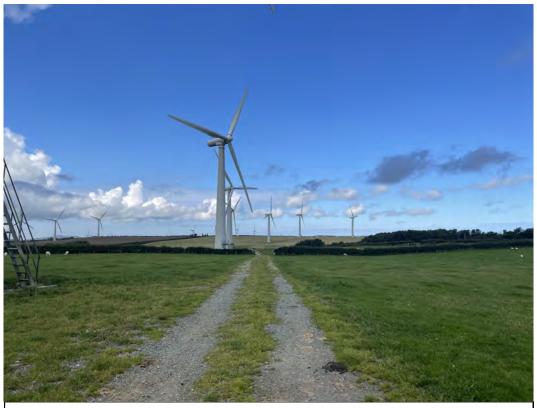
Photo 6—Wind Farm within fields to north west of Llyn Alaw.

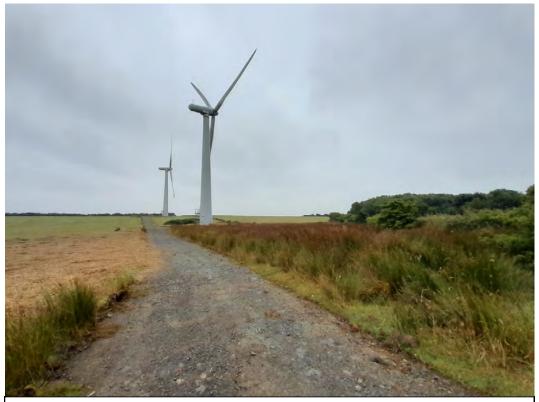
Photo 7—Wind Farm within field to north west of Llyn Alaw.

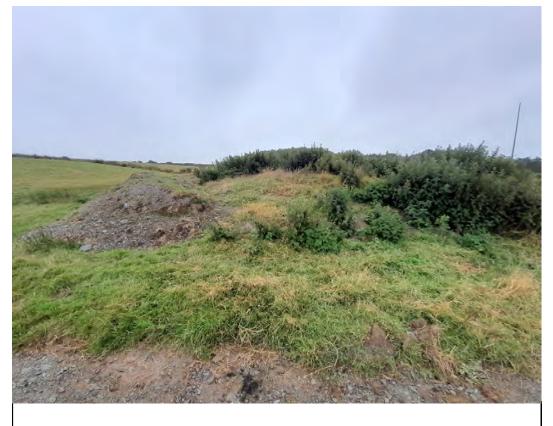
Photo 8—Stockpile as base of Wind Turbine. Alaw.

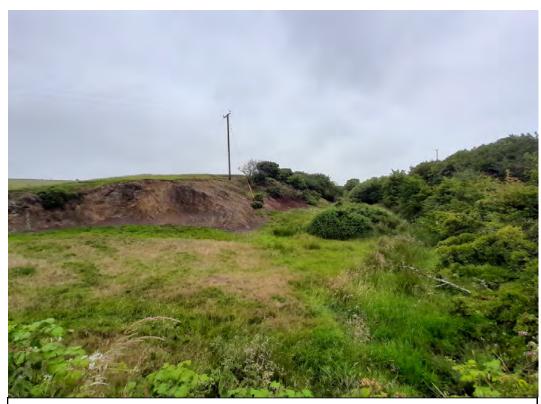
Photo 9—Possible remnant of historical quarrying activity north west of Llyn Alaw (Field 96).

Mineral Extraction	Several former small quarries are present on site, some of which may have been infilled. This represents a risk of Made Ground being present in these areas, or shallow bedrock.	Ground investigation should be undertaken to confirm the ground conditions in these areas.
